**AIRBORNE ELECTRONICS**  
**350A PROPELLER GOVERNOR**  
**INSTALLATION INSTRUCTIONS**  
**and SERVICE NOTES**

# AIRBORNE ELECTRONICS

## INSTALLATION INSTRUCTIONS

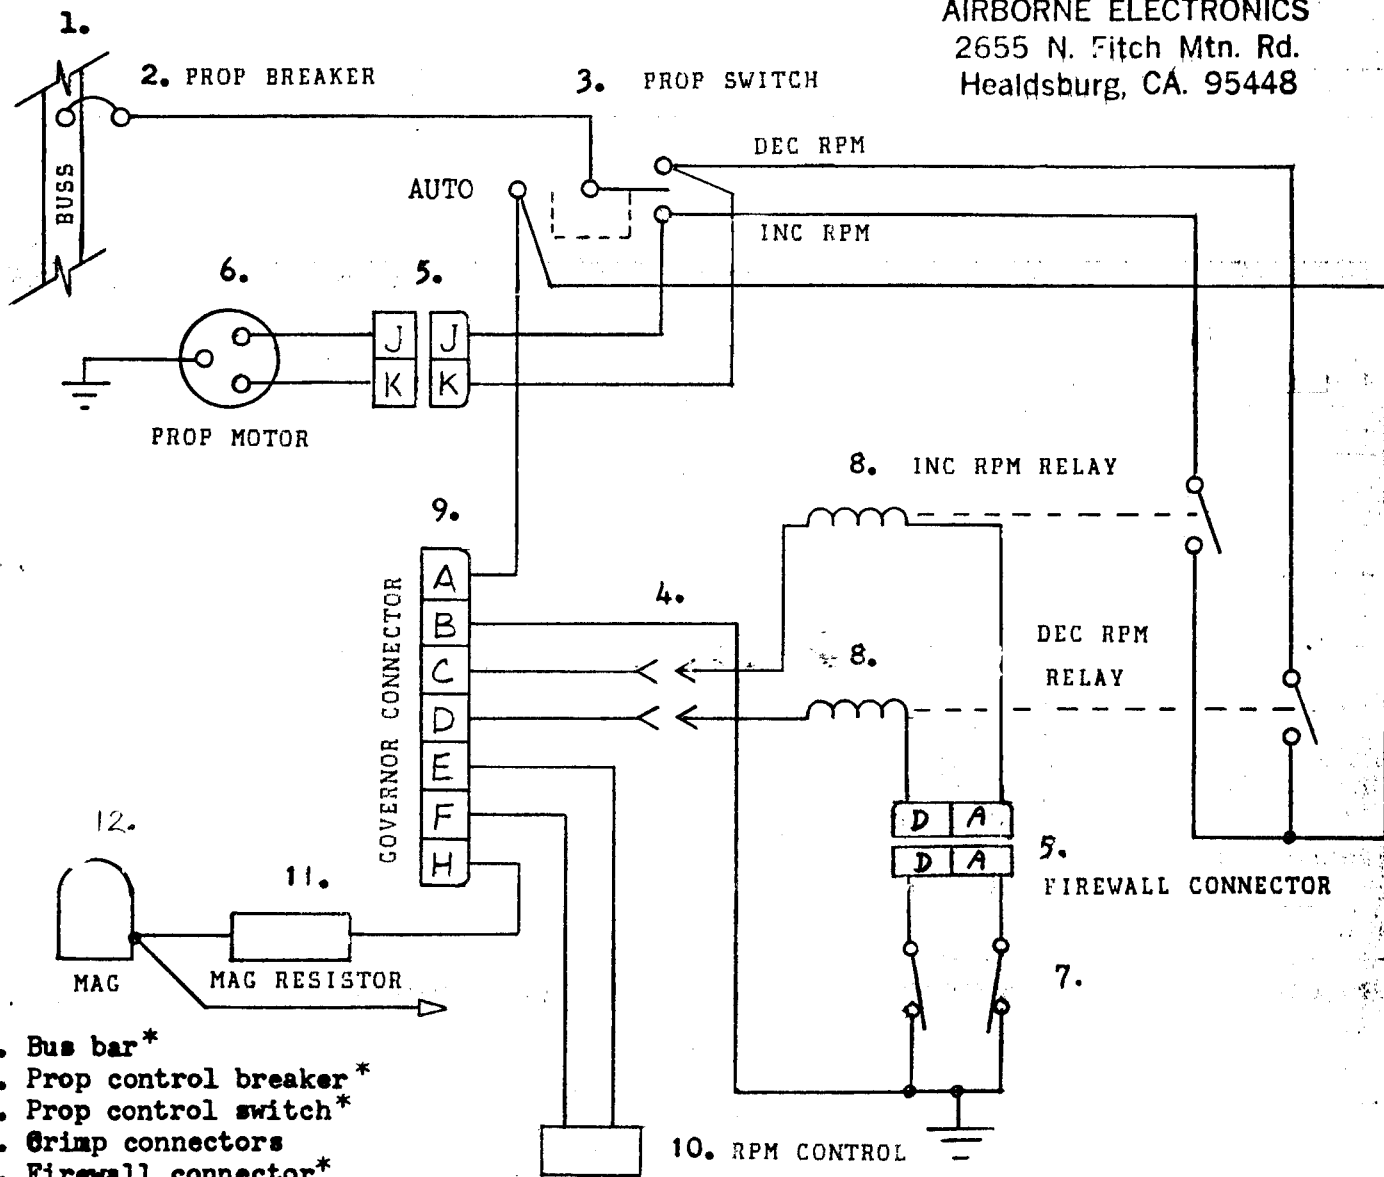
FIGURE A

- 1. Bus bar\*
- 2. Prop control breaker\*
- 3. Prop control switch\*
- 4. Crimp connectors
- 5. Firewall connector\*
- 6. Prop control motor\*
- 7. Limit switches\*
- 8. Relays\*
- 9. SSAPC cable connector
- 10. Panel control

11. Isolating resistor  
12. Magneto\*  
\* Existing parts, not supplied with Model 350A installation kit. Refer to 0350-0505 for supplied parts description.

troubleshoot the relay contact circuit. See wiring diagram, figure A.

The governor relay outputs are leads C and D. See figure A. These wires are connected to the 7 pin female governor connector at one end and to crimp connectors at their other ends. These outputs supply 12 volts to the appropriate relay when a pitch change is required. 12 volts at lead C should decrease pitch (increase RPM) and 12 volts at lead D should increase pitch (decrease RPM).

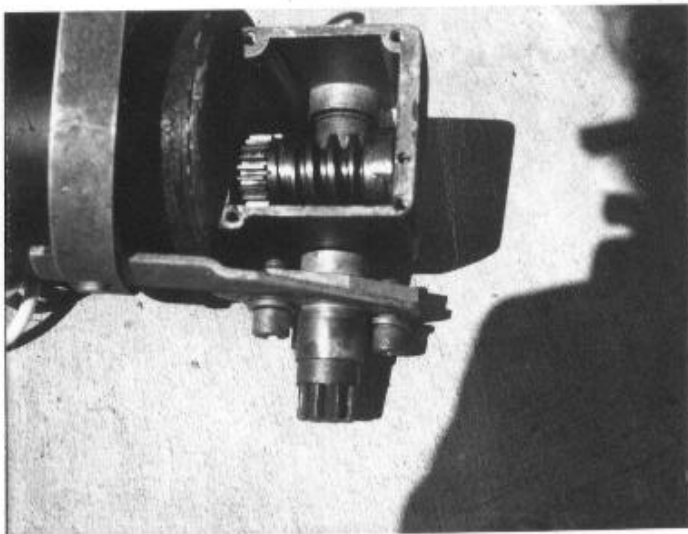
PROPELLOR PITCH  
MOTOR WITH FLAP  
ACTUATOR GEARS  
INSTALLED

215-210 propeller control motors have been found in the field with wrong gears installed. The worm gear and the output helical gear from the Bonanza flap actuator will fit the propeller motor but will result in a 3 to 1 smaller gear ratio. See figure B.

A simple test can be performed to determine if wrong gears are installed. With the engine not running, measure the time required to operate the propeller between pitch extremes manually. This time should be between 16 and 32 seconds. If flap actuator gears are installed, the time will be between 6 and 12 seconds. If wrong gears are suspected, the gear box cover can be easily removed without removing the motor.

The smaller gear ratio can result in unstable operation of the model 350A governor. Also, the smaller ratio is potentially dangerous whether or not the aircraft is equipped with a governor, as the reduced gear-motor friction can allow the prop to drift toward full coarse pitch with no voltage applied. In the event of an electrical failure, this situation could become serious.

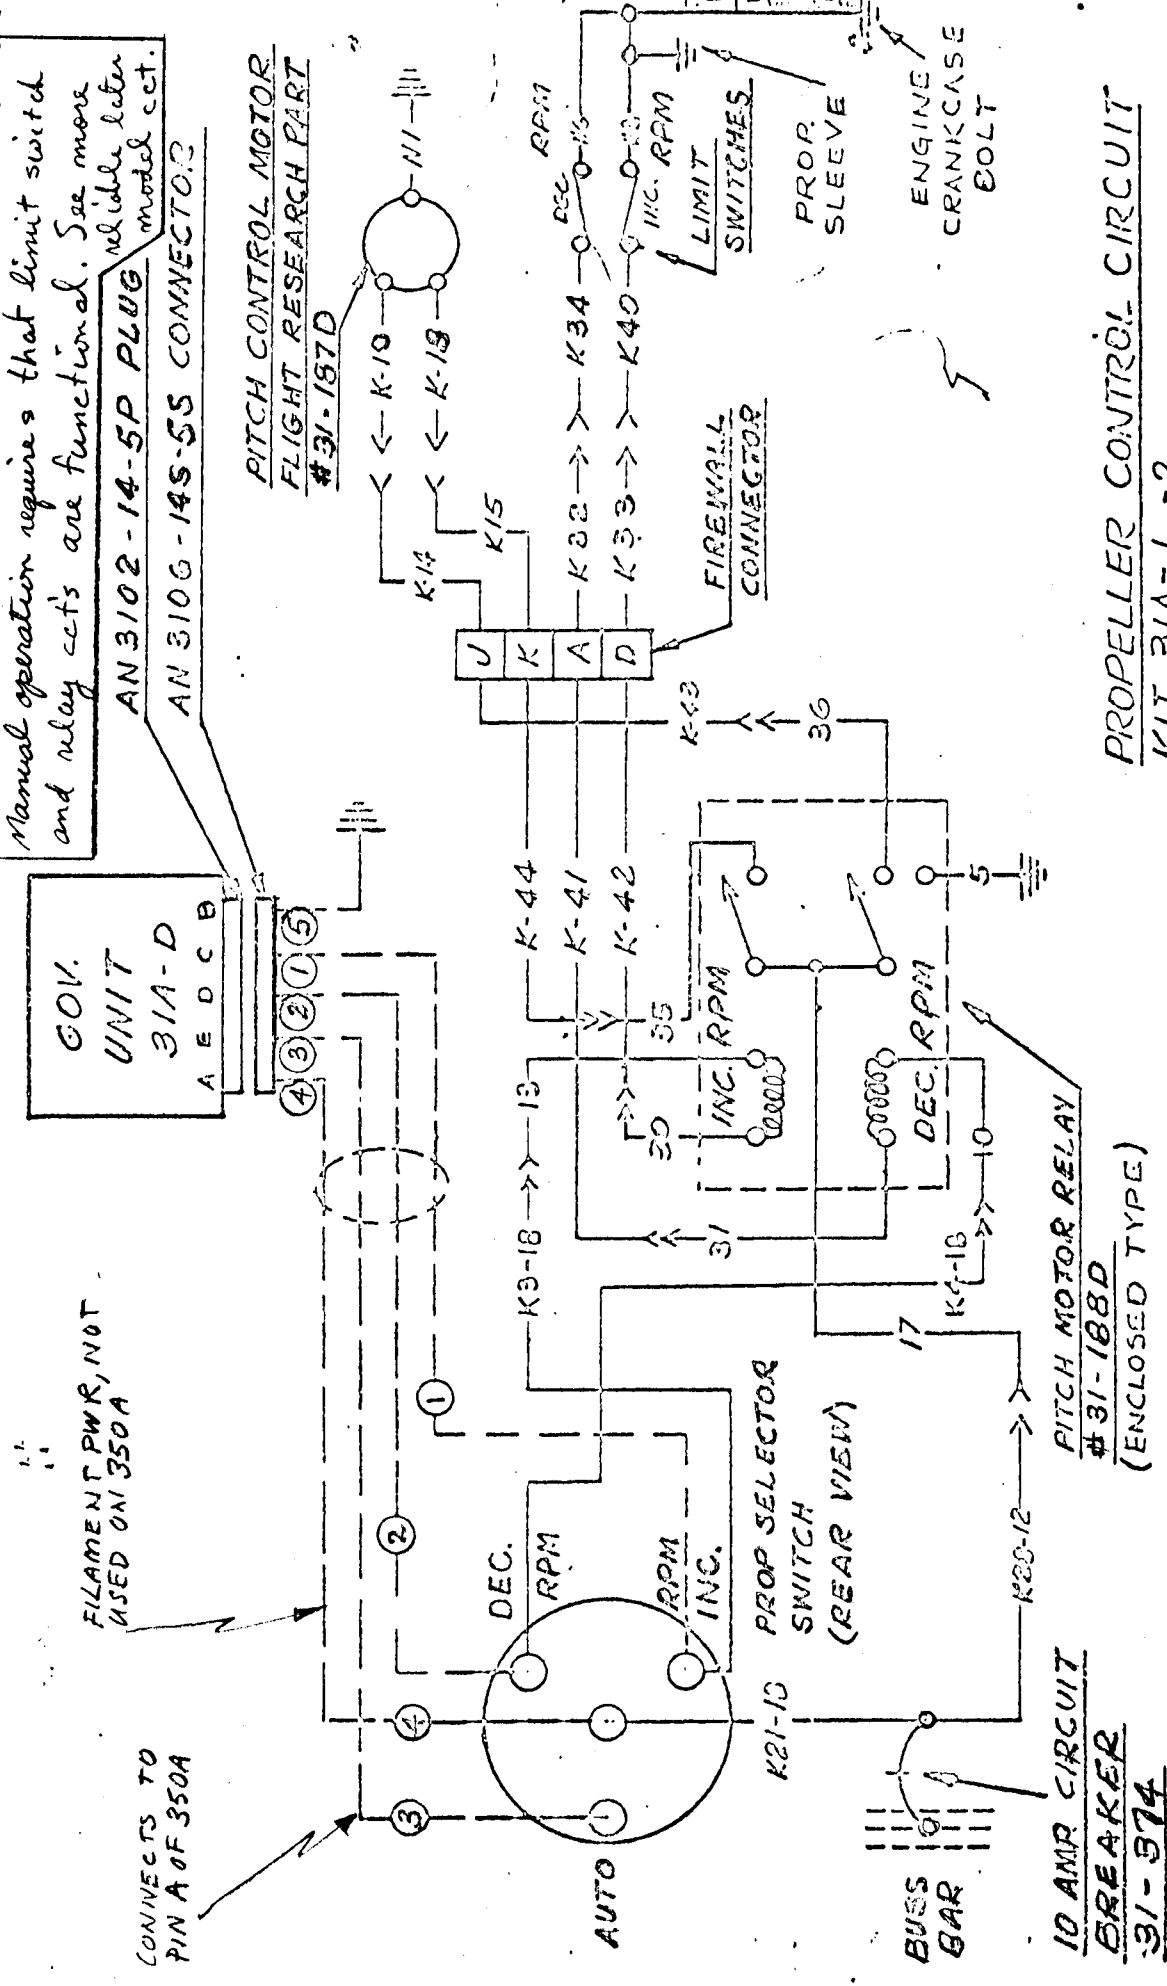
# FIGURE C

## ORIGINAL FLIGHT RESEARCH GOVERNOR WIRING; EARLY MODELS

PROPELLER CONTROL CIRCUIT  
KIT 31A-1,-2  
GOVERNOR UNIT 31A-D  
BEECHCRAFT DI-D1820

Straight 35's and A models through serial D-1820 were wired such that the panel propeller switch energizes the propeller control relays when switched to the INCREASE or DECREASE RPM positions. The relays, in turn, supply voltage to the pitch change motor. Aircraft D-1821 and later are wired with the panel switch supplying motor current directly. See figures C and D.

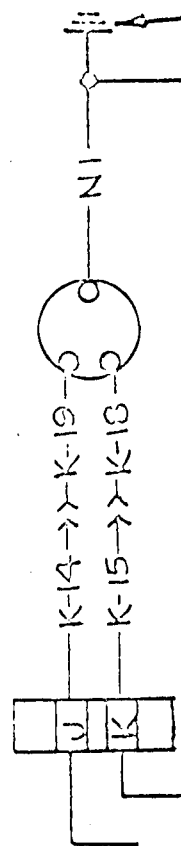
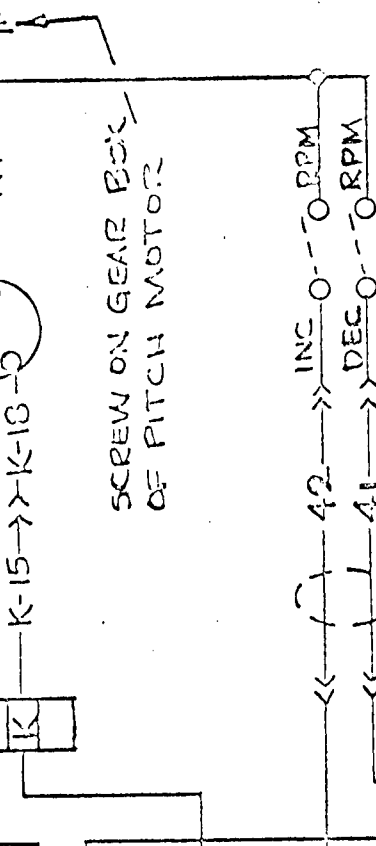
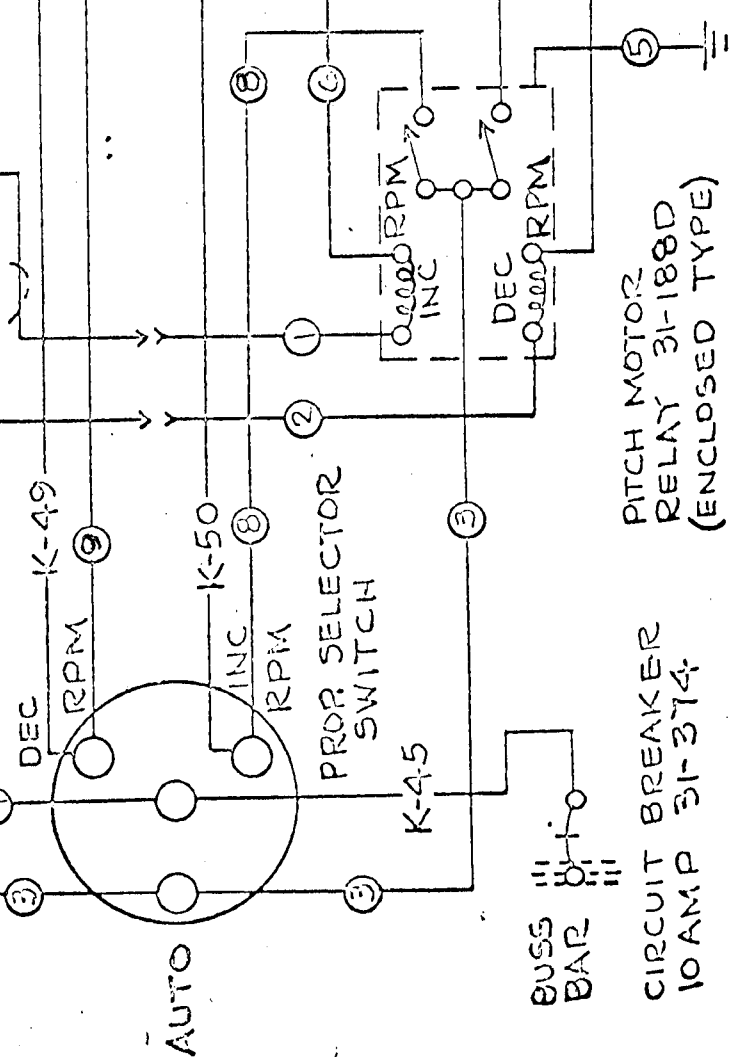
# FIGURE D

PITCH CONTROL MOTOR  
FLIGHT RESEARCH  
PART # 31-187 D

SCREEN ON GEAR BOX OF PITCH MOTOR

THRU GROMMET HOLE IN FIREWALL  
LIMIT SWITCHES

PITCH MOTOR RELAY 31-188D (ENCLOSED TYPE)

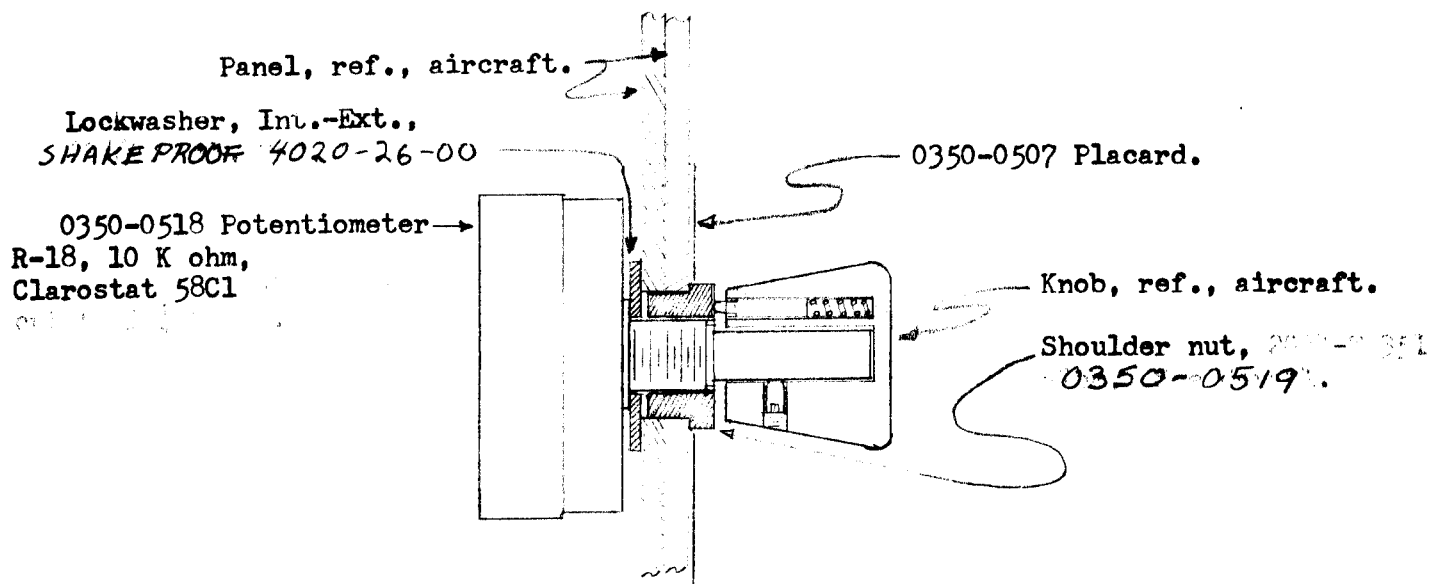
# FIGURE E

## — INSTALLATION —

12 O'clock

- a. Replace the control column collar.
- b. Dry fit the prop control placard over the shoulder nut to check clearances.
- c. Remove the release paper from the placard and stick in place.
- d. Rotate rheostat shaft full CW and then install knob with the dot at 12 o'clock. The knob should be installed so that the detent pall is just depressed.

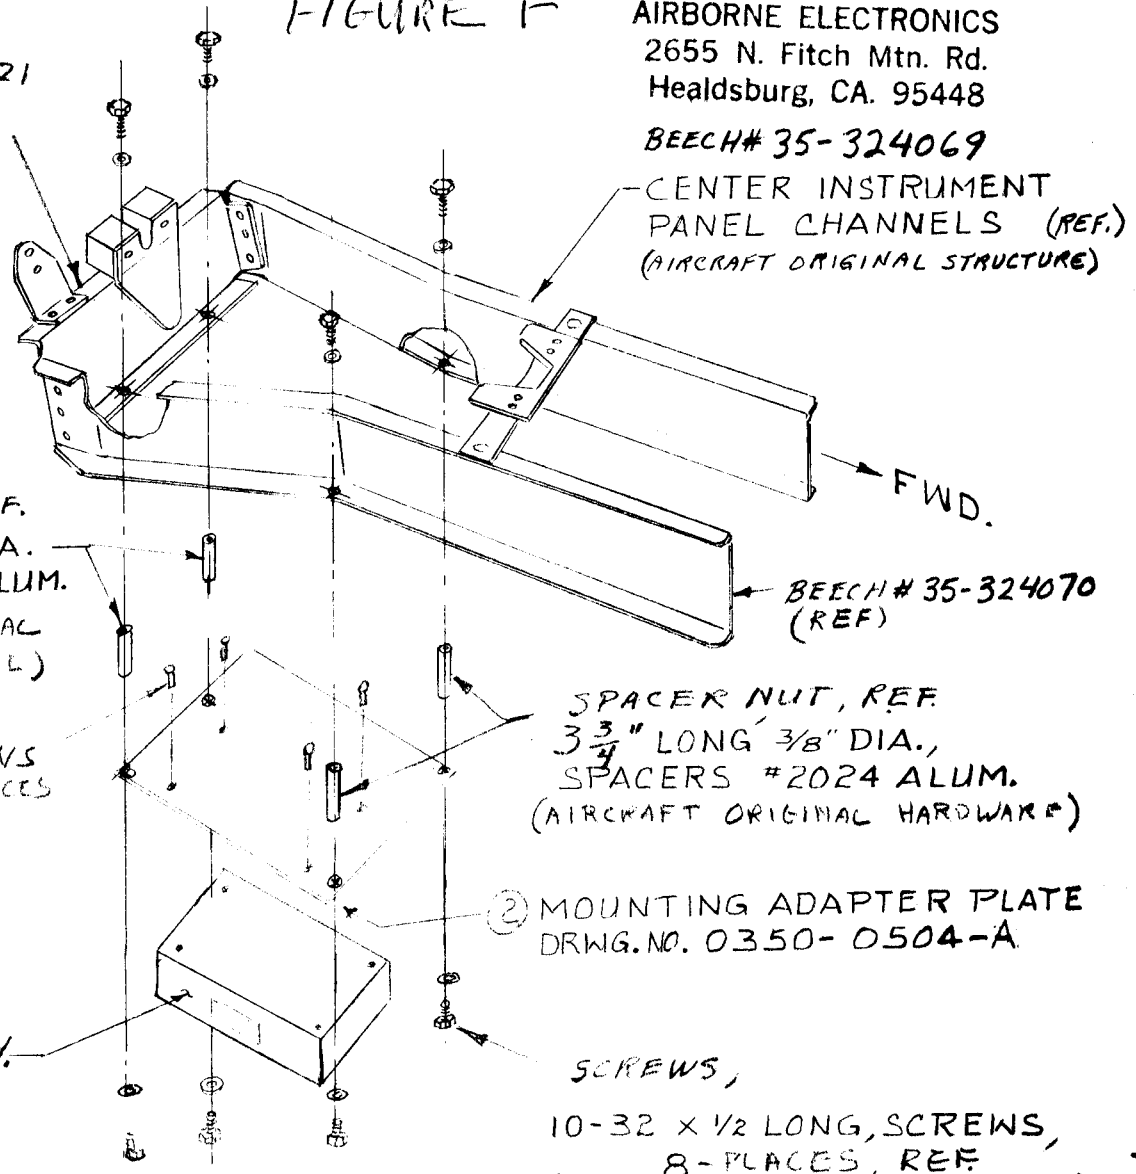
① PROP CONT. ASSY.

SCREWS,  
10-32 X 1/2 LONG, SCREWS,  
8-PLACES, REF  
(AIRCRAFT ORIGINAL HARDWARE)
